Mach Lake Dam (MO 30133).
Mississippi - Kaskaskia - St. Louis River
Basin, Perry County, Missouri. Phase I
Inspection Report.

MACH LAKE DAM
PERRY COUNTY, MISSOURI
MISSOURI INVENTORY NO. 30133

PHASE I INSPECTION REPORT
NATIONAL DAM SAFETY PROGRAM

April, 1981

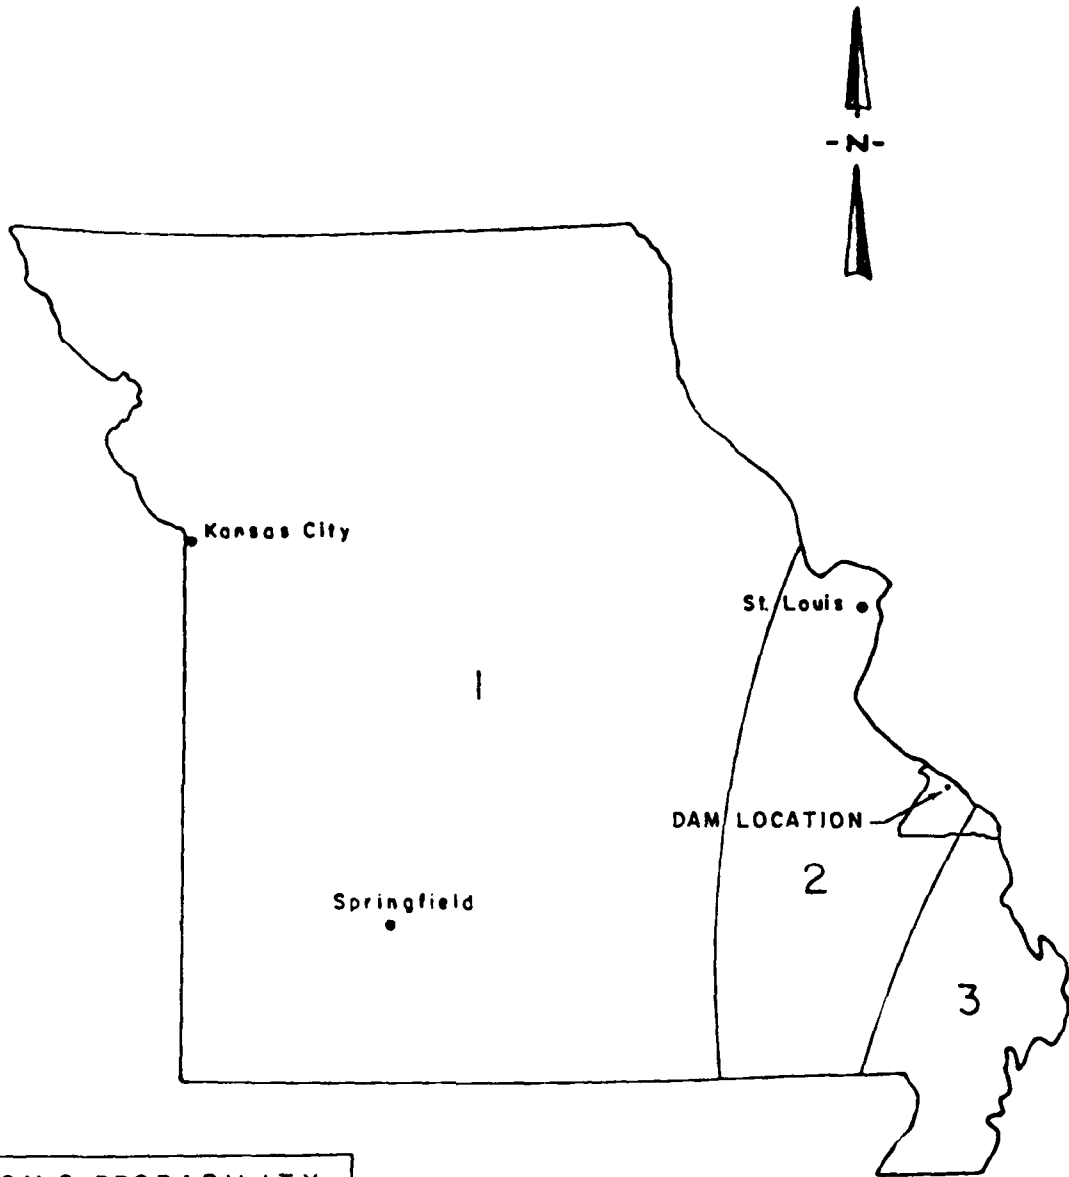
| SEISMIC PROBABILITY | |

The "Geologic Map of Missouri" indicates several normal faults located north and west of the site. The site is located in seismic zone 2 (moderate damage zone) but is close to the boundary of zone 3 (major damage zone, see Sheet 3 of Appendix B).

The structure is located in seismic zone 2. It is recommended that the prescribed seismic loading for this zone be applied in stability analyses performed for this dam.
